Re : LMS 2503 – Terravita Place
868 Cassiar Street, Vancouver, BC
Our Reference : 01-448

As requested, an on-site inspection was performed on two separate structures that included three units. The following was found:

JPJ/sd (Inspection 01-448 Dorset re Terravita)

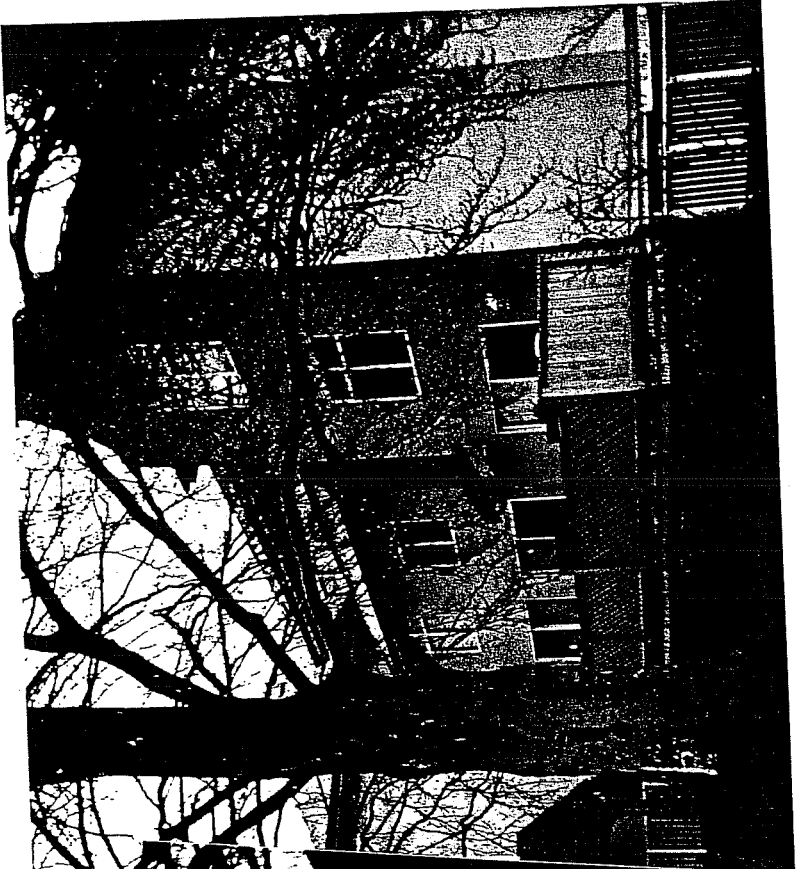
1B

UNITS # 43 & #44

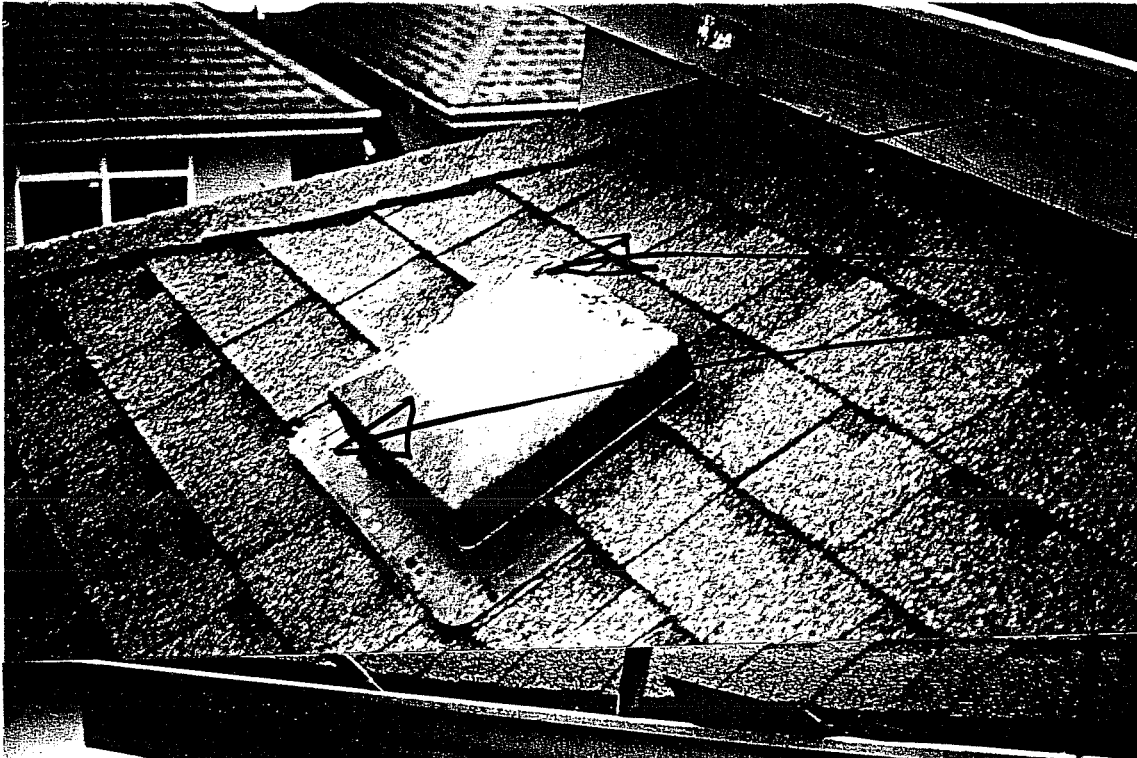
3

- (8) The gutters' down pipe installation is such that the flow of water is in some locations detrimental to the shingles and components (no Photos), and in a minimum of one location the lack of down pipes, in combination with poor component installation, are resulting in leaks (see Photos # 1, 3, 4 & # 5). The leak into Unit # 44 is an example of this condition.

VENTS ABOVE LEAK IN UNIT #44

— WATER
RUNNING FROM
GUTTER'SPOUT

— POOR
— INSTALLATION
ALLOWS WATER
TO ENTER

Note: The roofing contractor assisting Roof Tech on site has corrected the poor vent installation and has installed short lengths of down pipe (adequate to bypass the vents). This should correct this leak location.

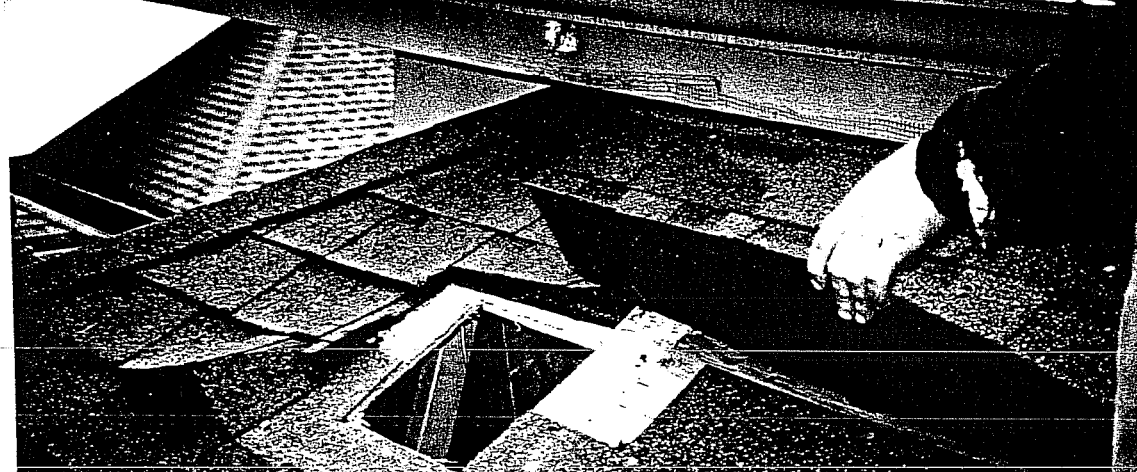
- (3) Exposed nail heads penetrating through the shingles (see Photos # 6 & # 23), plus other nail damage (see Photo # 24)
- (4) Felt underlay only under eaves (see Photo # 20), with no coverage in mainfield area (Photo # 4 & # 34) or at ridges (Photo # 18) or at valleys (Photo # 27).

NO "FELT"
UNDERLAY
BETWEEN
PLYWOOD &
SHINGLES

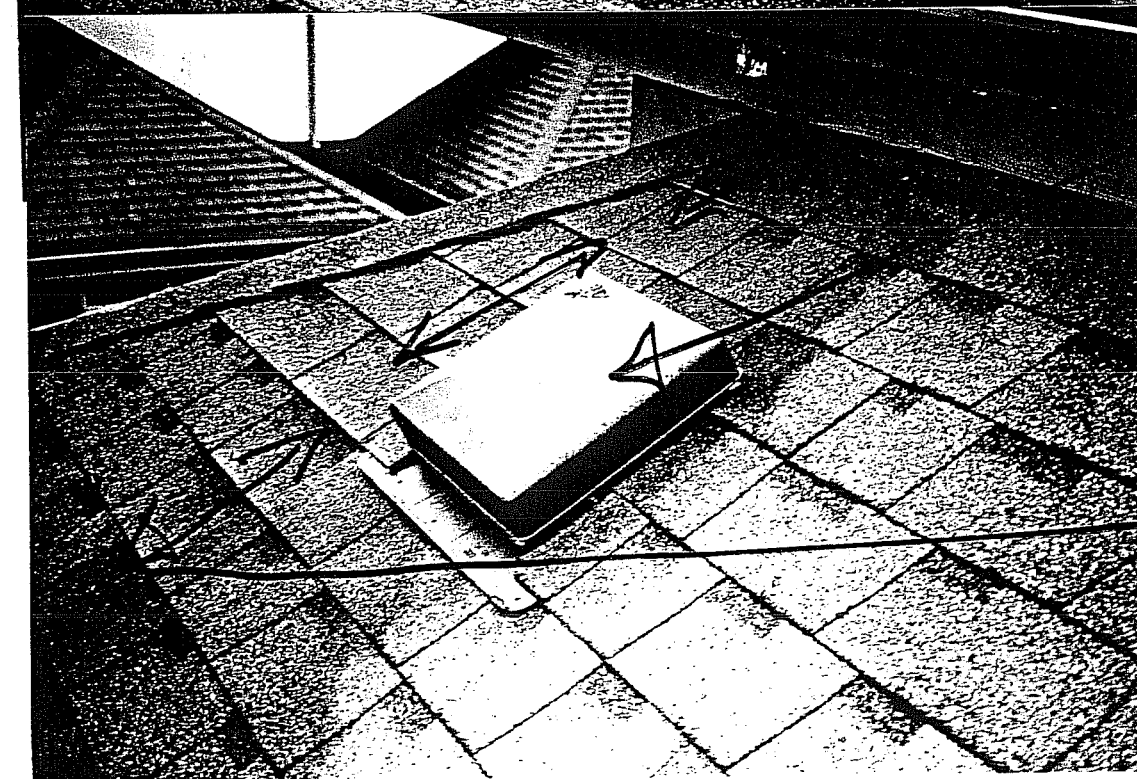
5

RE-INSTALLED
CORRECTLY

AN EXTENDED
DOWNPIPE IS
— REQUIRED

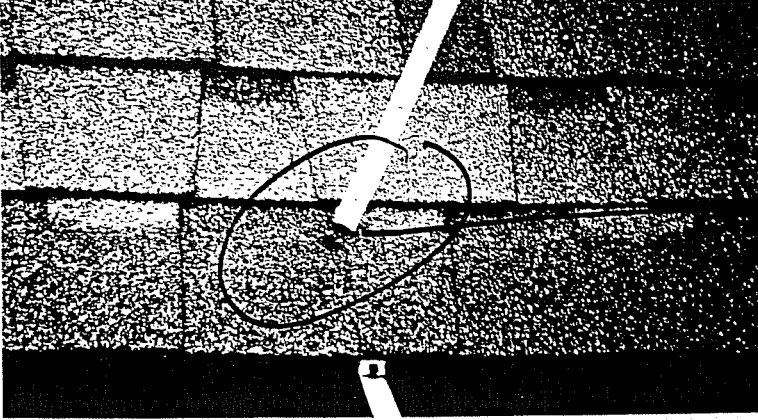
— NAIL HEAD
Protruding through
the shingles

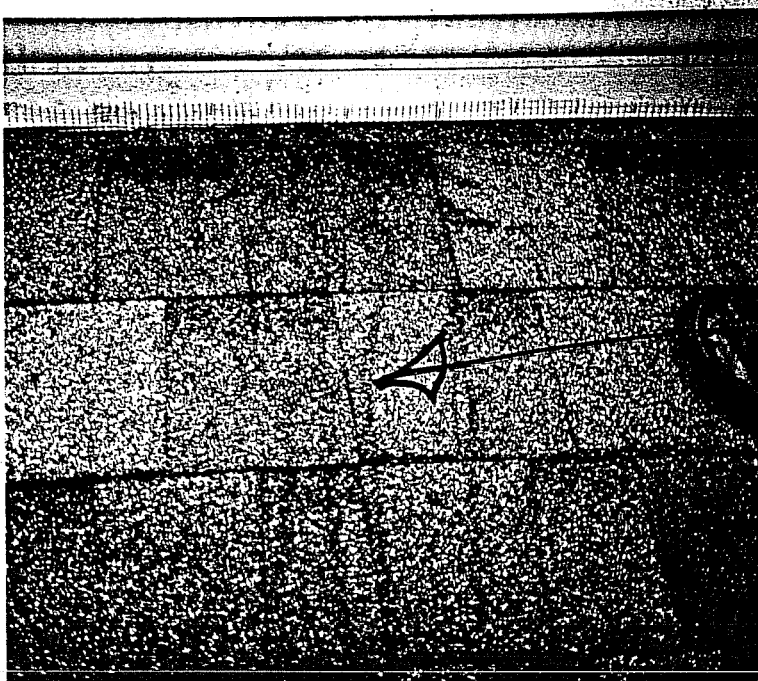
— STAINS,
From water
Running behind
the gutter
6

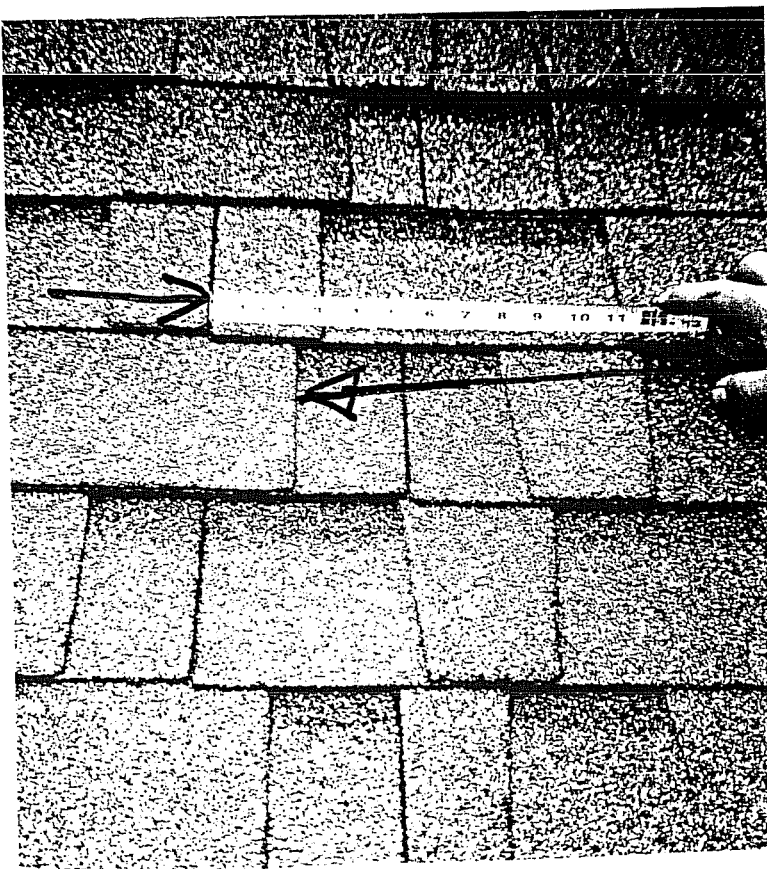
7

- (1) Poor vent stack and component installation. (See Photos # 3, 38, 39 & # 40)
- (2) Poor mainfield shingle end laps, ranging from 3" (inches) to 6 1/2" (inches) in many locations. (See Photos # 7, 21, 22, & #36)

— 3"(INCH) side lap

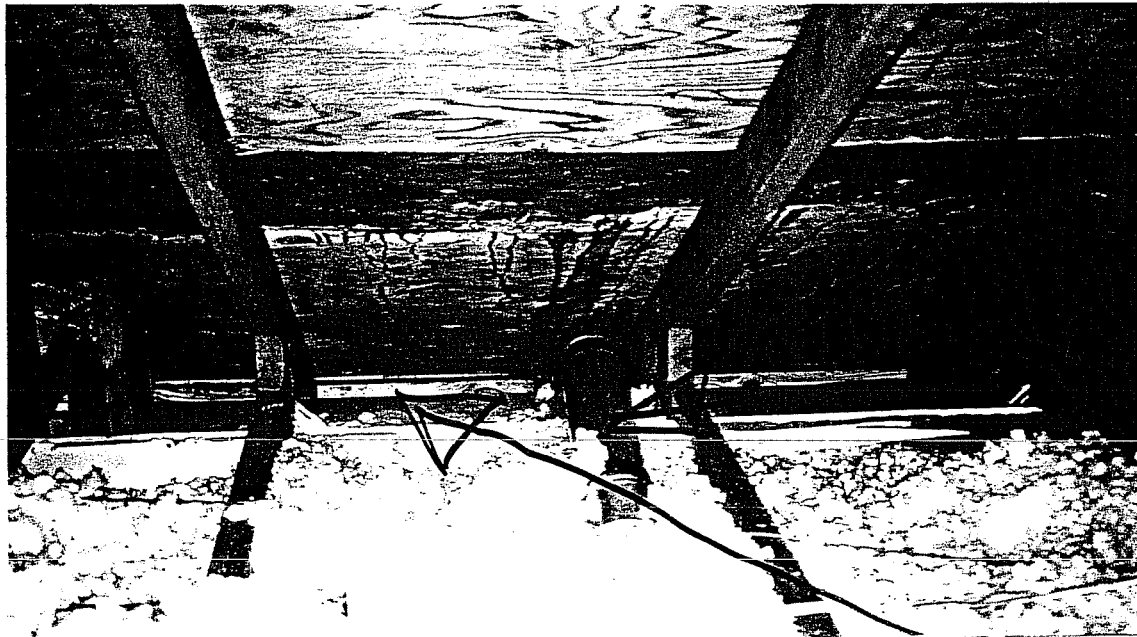
9

The exhaust vents are installed to flow out of the soffits (see Photos # 9, 42, 43, & 44). Unfortunately, when clothes dryers, etc. are exhausting moist air, it exists the vents and is sucked into the soffits, then runs along the deck underside towards the ridge vents resulting in varying degrees from damp dry to saturated substrates (see Photos # 15, 16, 28 & #35). This moisture travels between the plywood and shingles rusting nails, etc., and forms into leaks at windows (see Photos # 14 & # 41) and into interior or ceiling spaces (see Photo #30).

TYPICAL OF
VENTS
@ SOFFITS, SEE
PHOTOS#

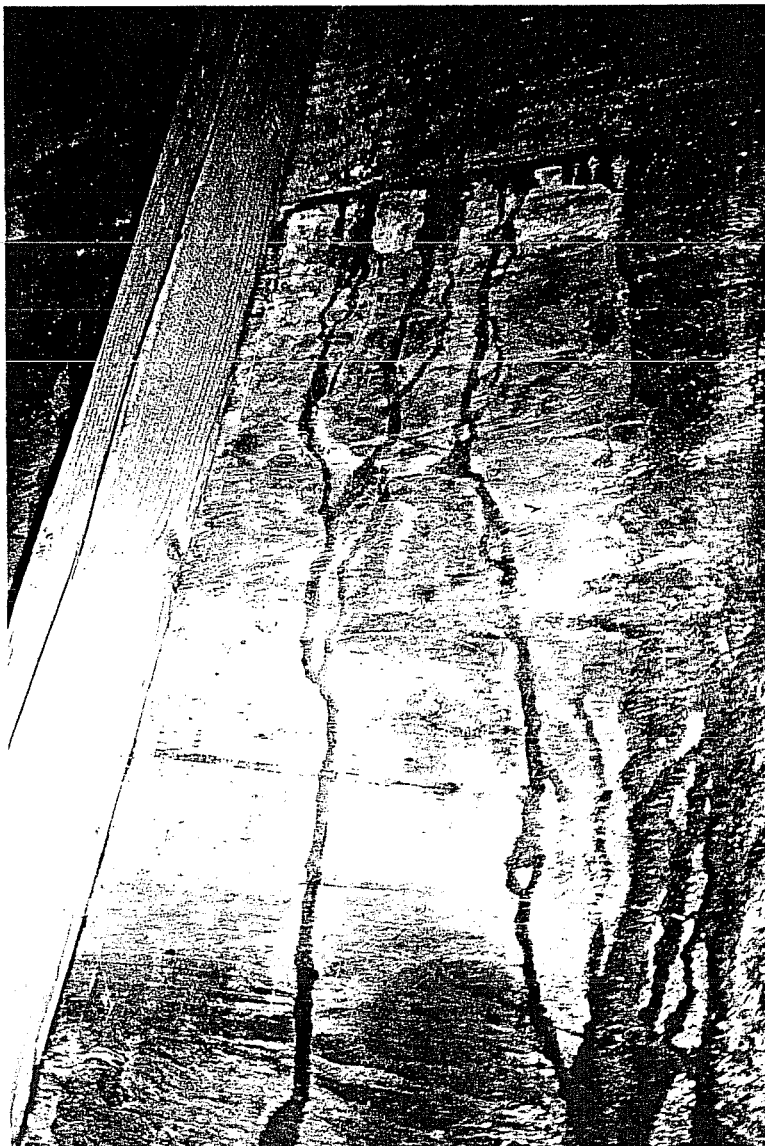
12

UNIT #44 | STAINS FROM:
(A) SOME IF NOT MOST
OF THIS STAINING IS
FROM INSTALLING "USED
PLYWOOD"

(B) SOME MAY BE
FROM THE ROOFING
&/OR VENTILATION
CONCERNS AS NOTED
IN UNITS #43 & #57

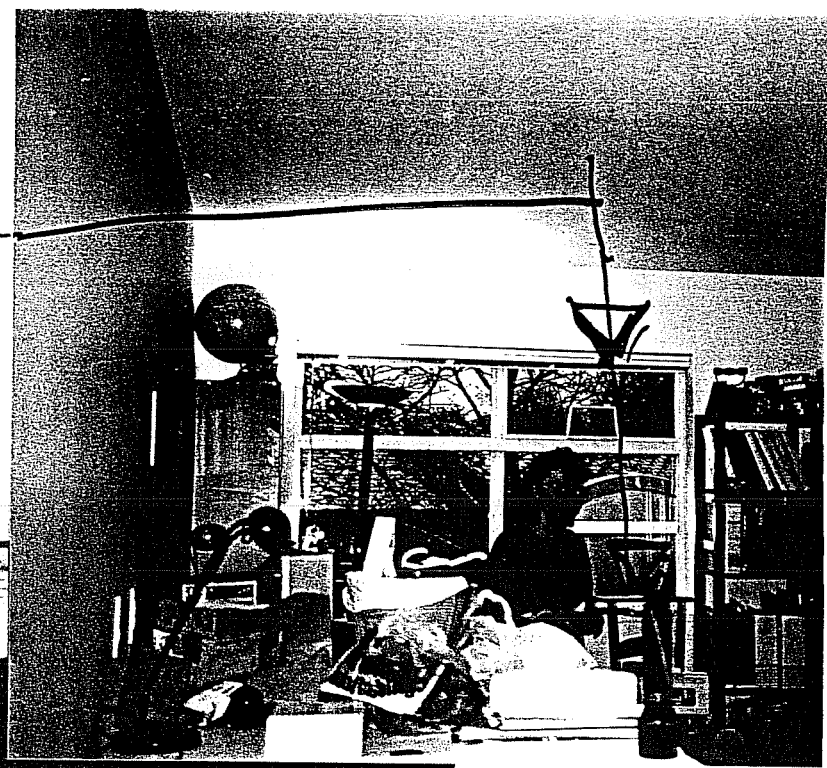
14

UNIT #43 WATER
STAINING OCCURS ON
TOP @ SILL AREAS

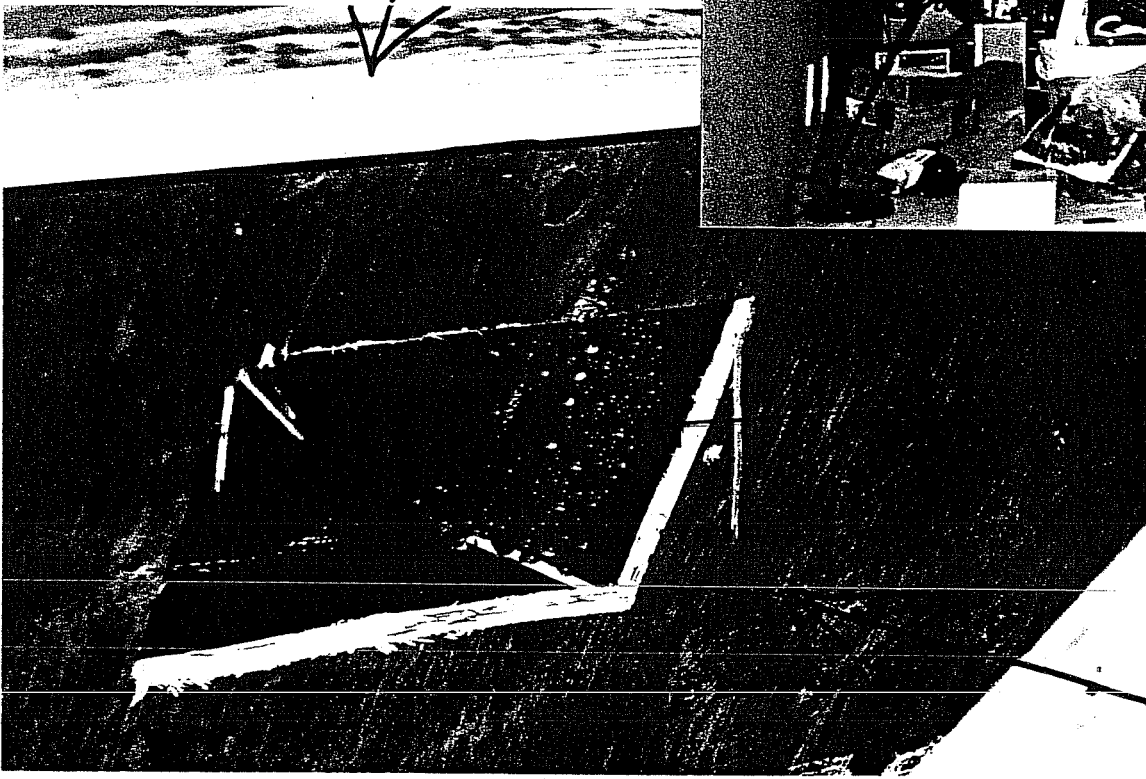
15

NOTE;
BEADS OF WATER
& FRESH SAWCUT
"NEWLY INSTALLED
VENTS"

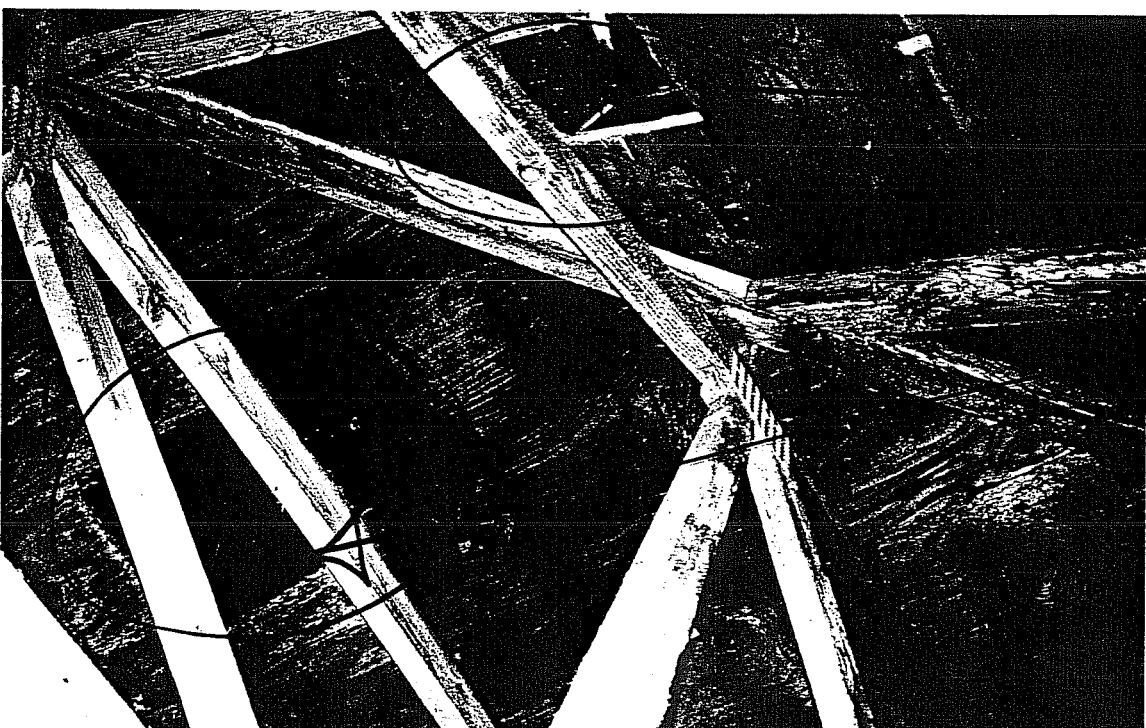
16

"OTHER" VENT
HAS "OLD"
SAWCUT

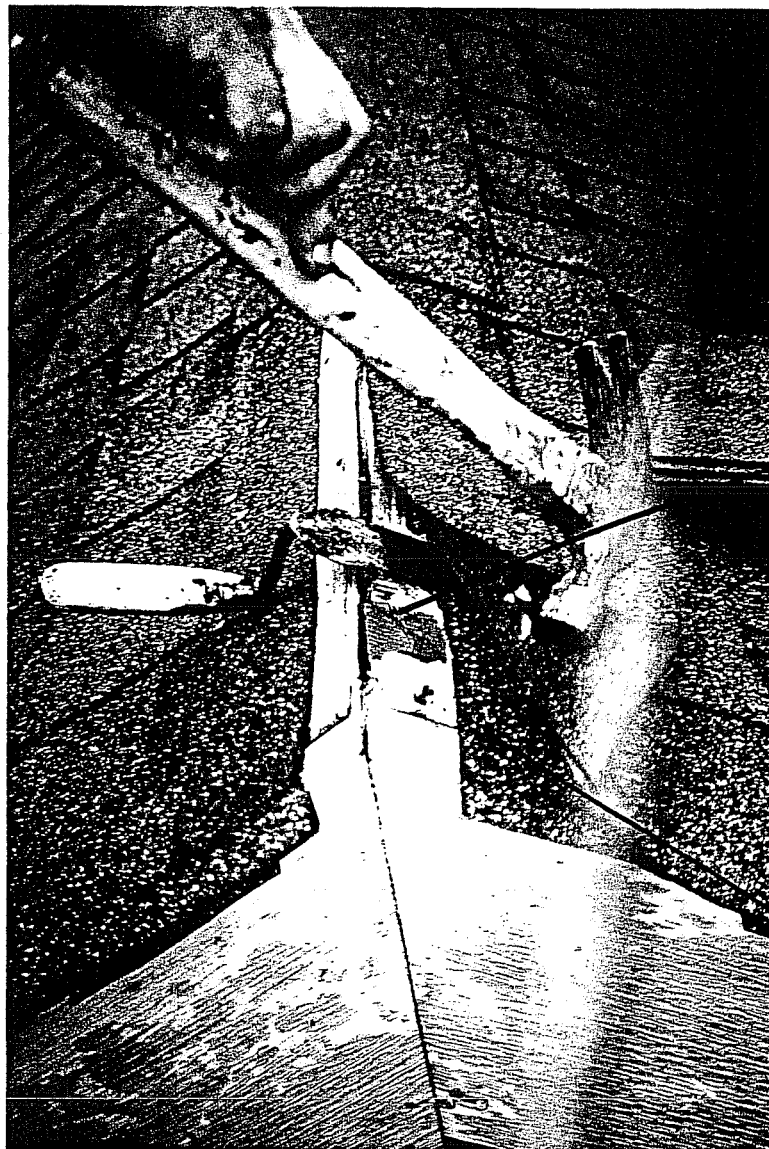
18

NO "FELT"
UNDERLAY

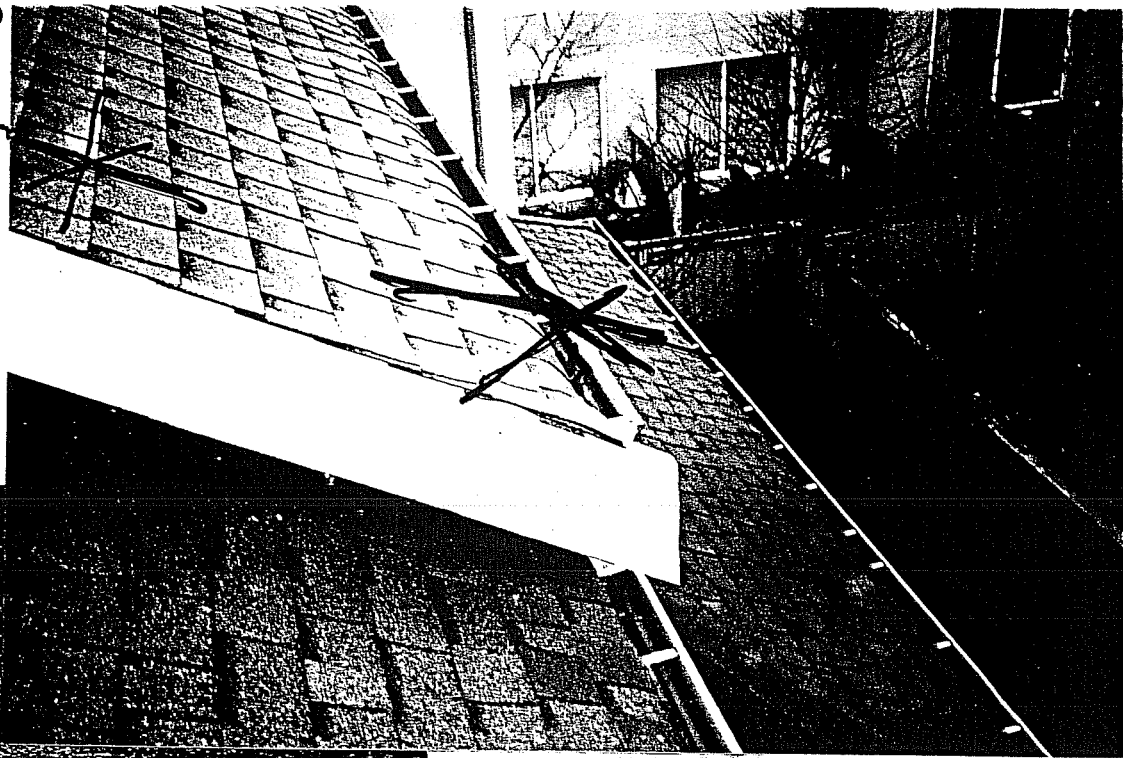
20

FELT
UNDERLAY
@ EAVES ONLY
1m +-.

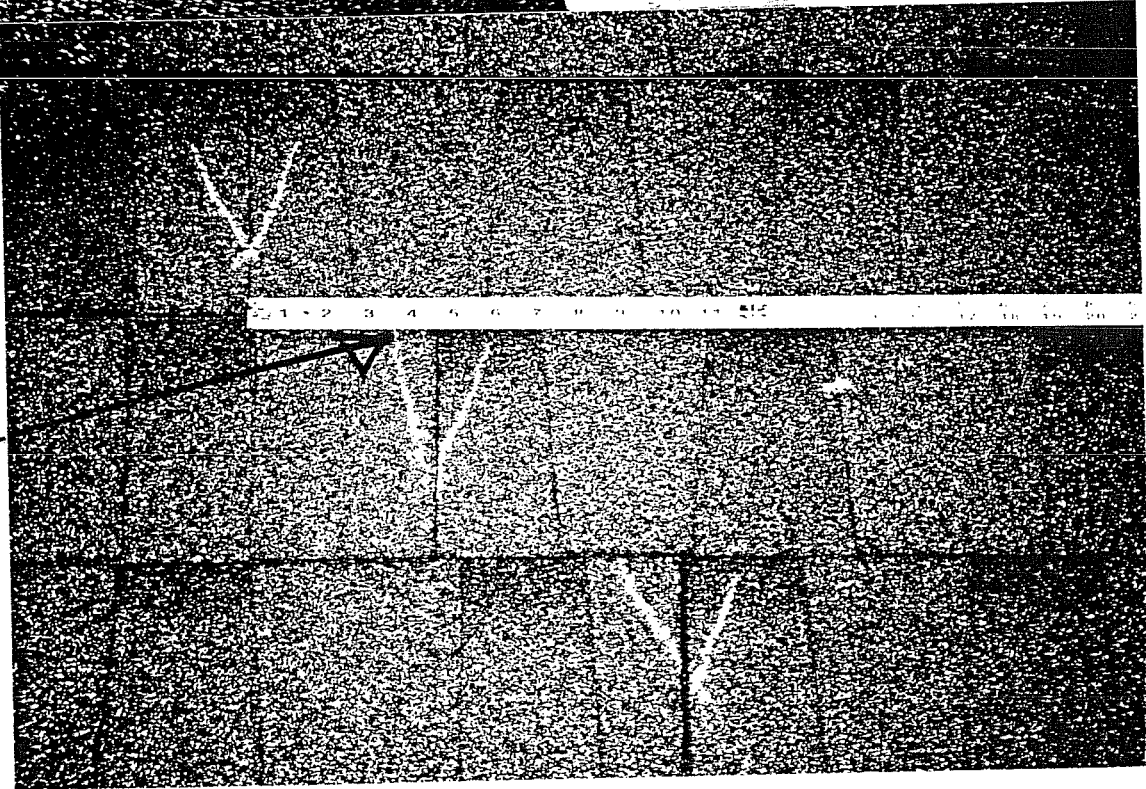
3" (INCH) SIDE LAPS
4 1/2" (INCH) SIDE LAPS

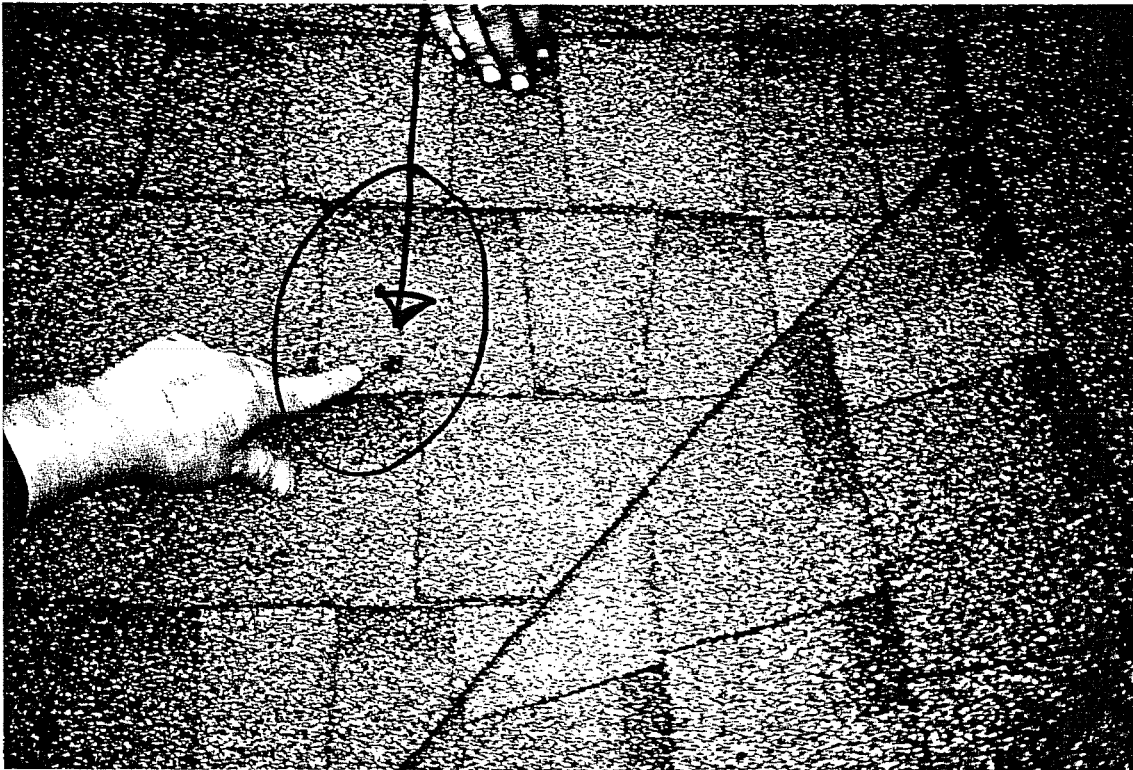
23

TYPICAL EXAMPLE OF NAIL
HEAD PENETRATING THROUGH
THE SHINGLES

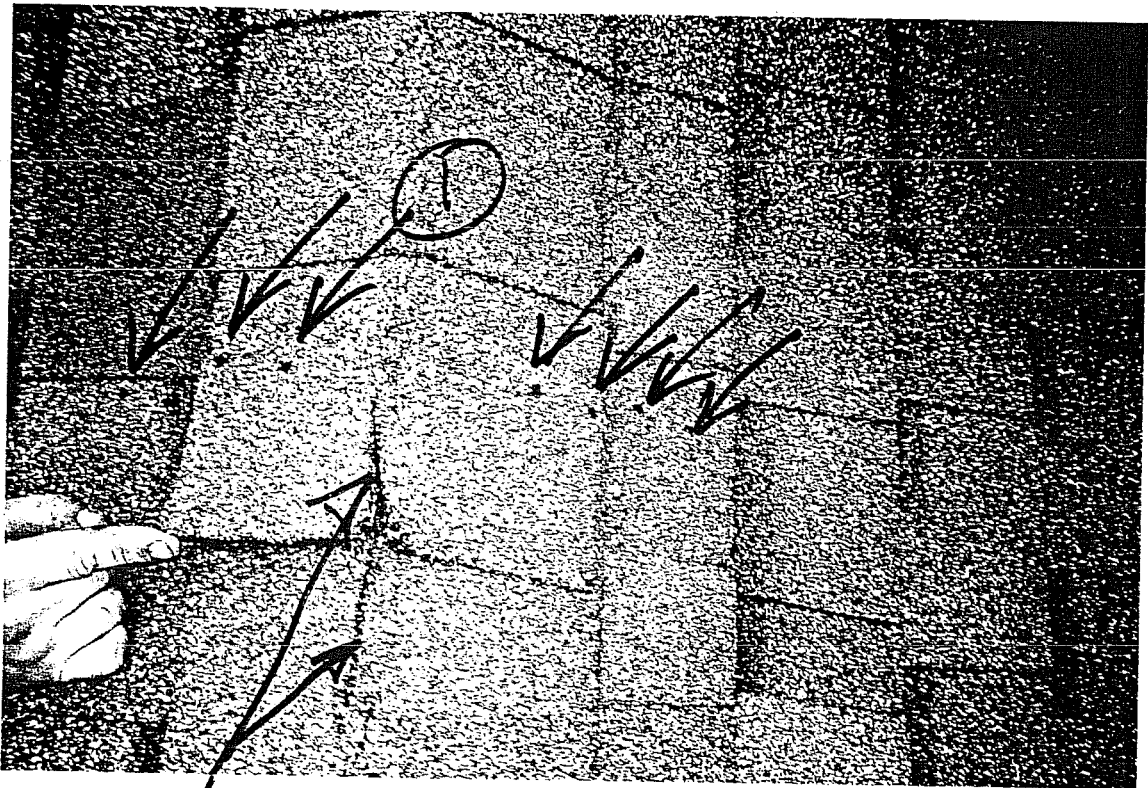
24

SPLIT & DAMAGED RIDGE CAP

① → NAIL HOLES LIKELY LEFT OVER WHEN
THEIR SECURITY LINE'S WERE NO
LONGER REQUIRED

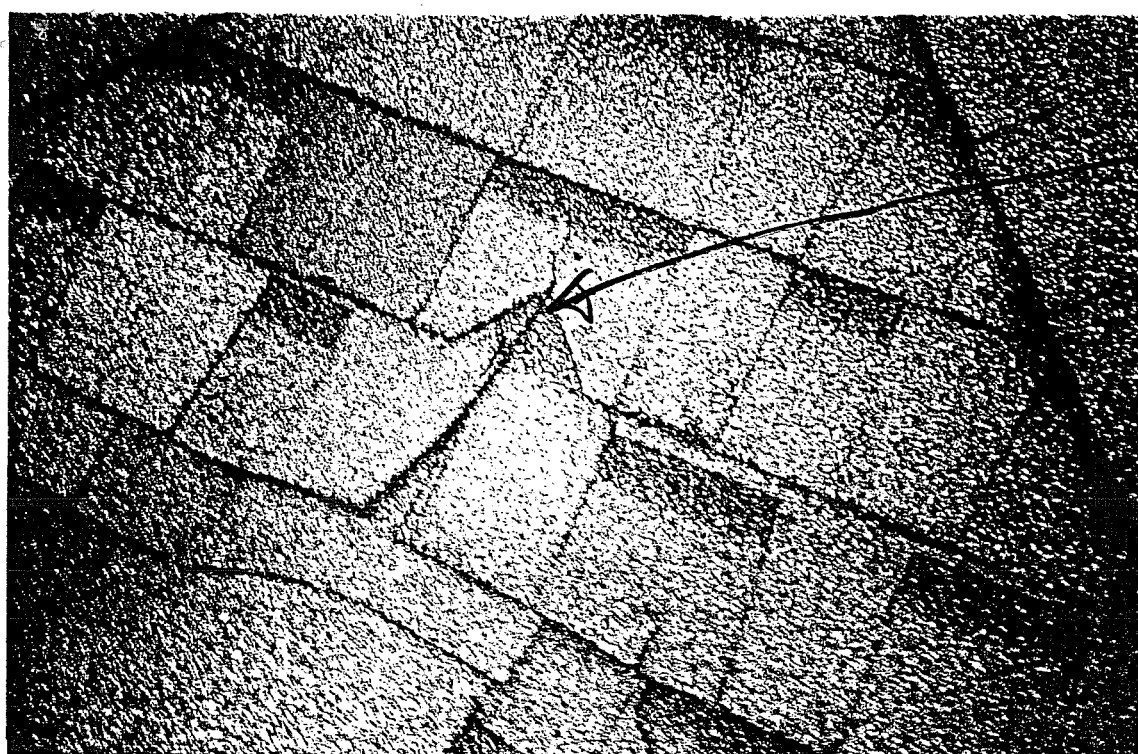
26

- (6) The shingle nailing pattern is incorrect and the nail heads are starting to rust (see Photo #38).
- (7) Some of the installed sheet metal flashing is resulting in stucco damage (see Photo # 26).

POORLY
INSTALLED
SPLIT RIDGE
CAP @ JUNCTION
TO SLOPED ROOF

WATER RUNOFF
RESULTING
IN STUCCO
DETERIORATION

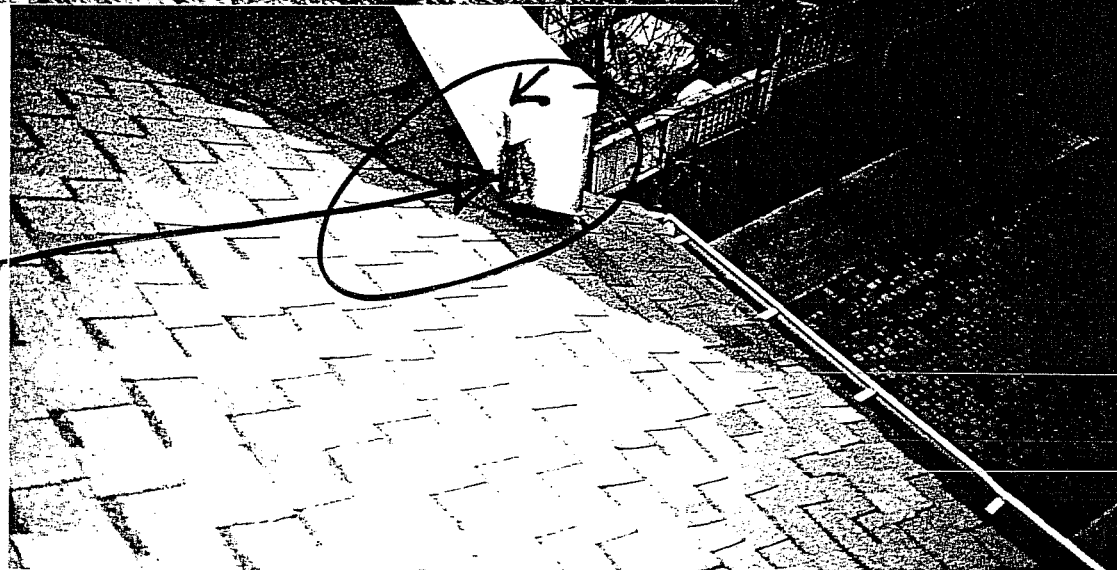
27

- (5) The ridge cap installations are poorly installed (see Photo # 27). Further the "closed cut valley" installation is required to run up 12" (inches). A few of the valleys checked have 6" (inches) coverage only (see Photo #27) and none of the valleys have a felt underlay.

(A) 6" (INCHES)
UNDER LAP
OF SHINGLE @
A VALLEY.
(B) NO "FELT" @
VALLEY

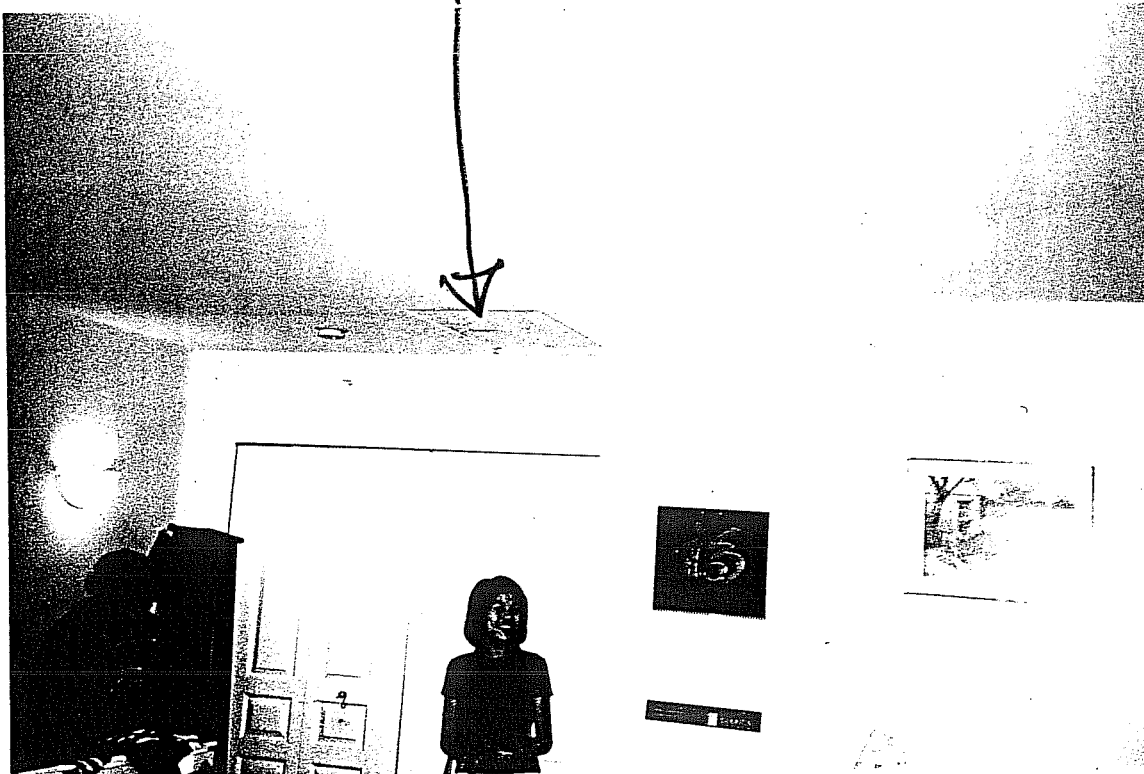
UNIT #57 CEILING LEAK.

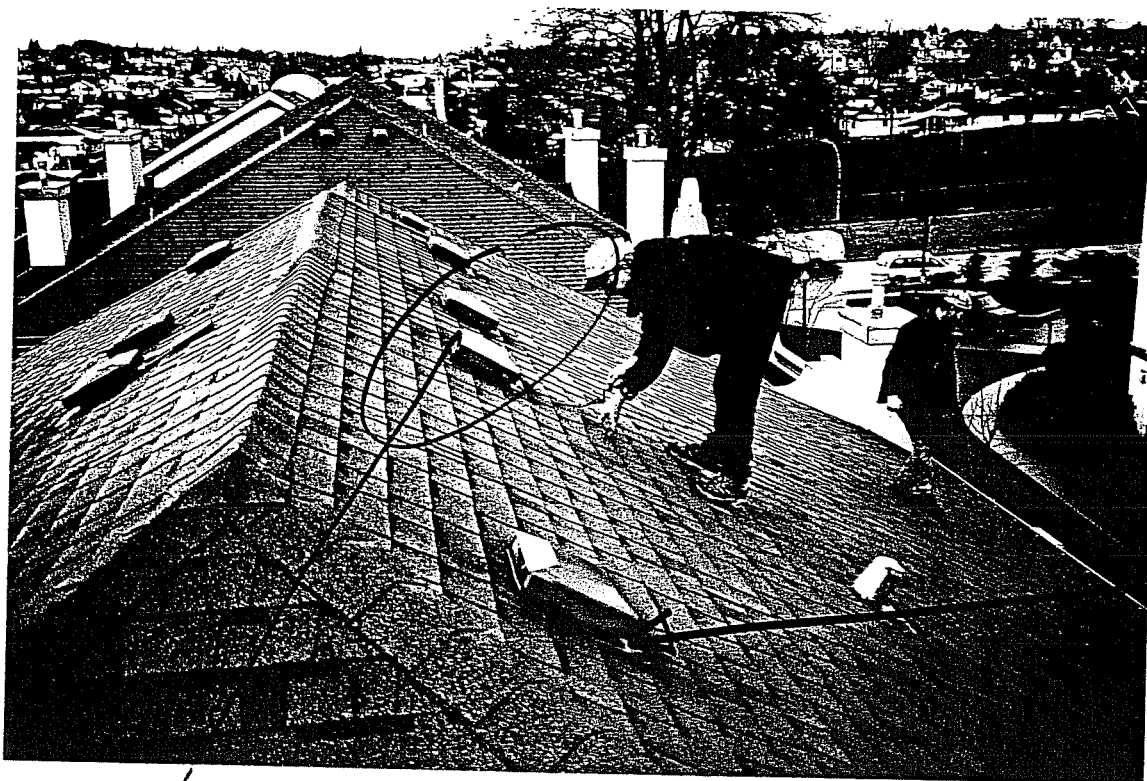
31

- (9) The attic ventilators at the ridges (see Photo #31) are nailed at the bottom flange only. This indicates that the vents were installed after the shingle installation. (Rather than weaved in between shingle layers) and the exposed nails are rusting.
- (10) The rusting of the nails (Photo # 37) is predominantly due to moisture accessing the underside of the shingle through the plywood side and butt joints. (See Photos # 16, 28 & # 35.)
- (11) The same moisture access (as noted in Item #10) is also assisting in the minimum adhesion of the self adhesive strip on the shingles (Photo # 37).

RUSTING
NAILS @
- BOTTOM of
VENTS only

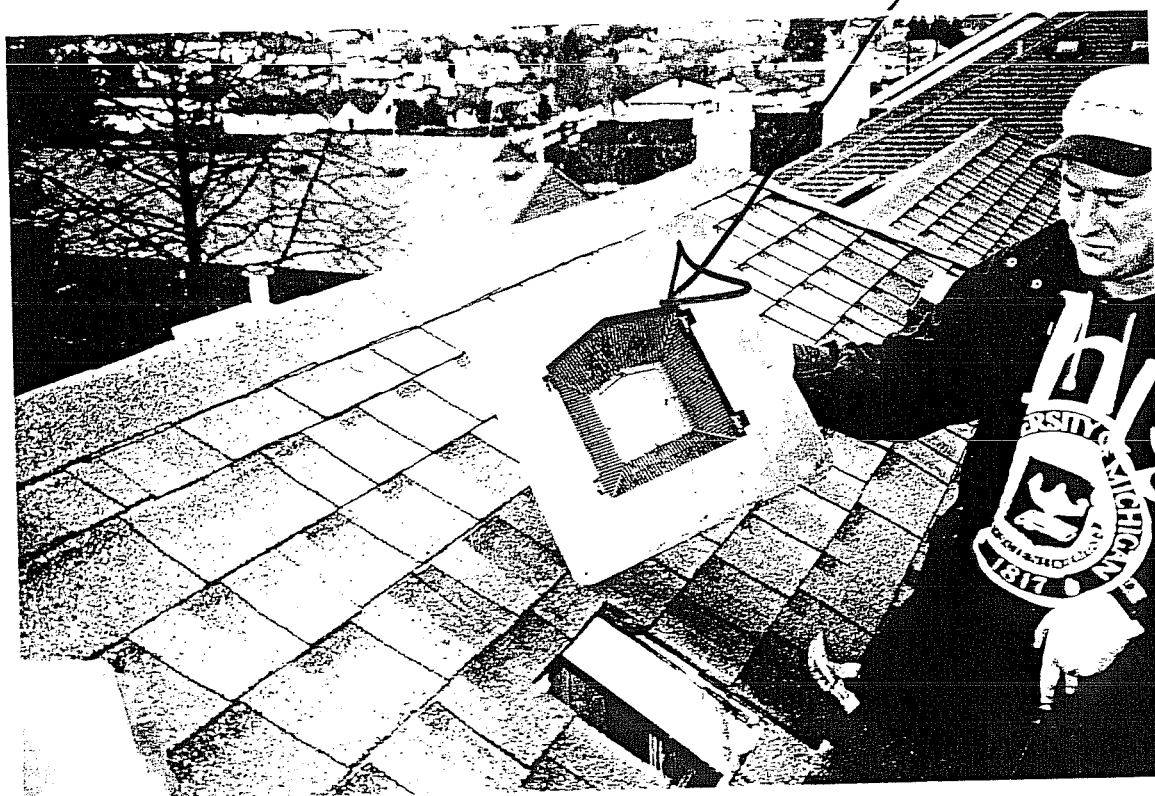
32

VENT OVER CELLING LEAK.
(PHOTO # 30) & WATER DROPS ON
UNDERSIDE OF VENT

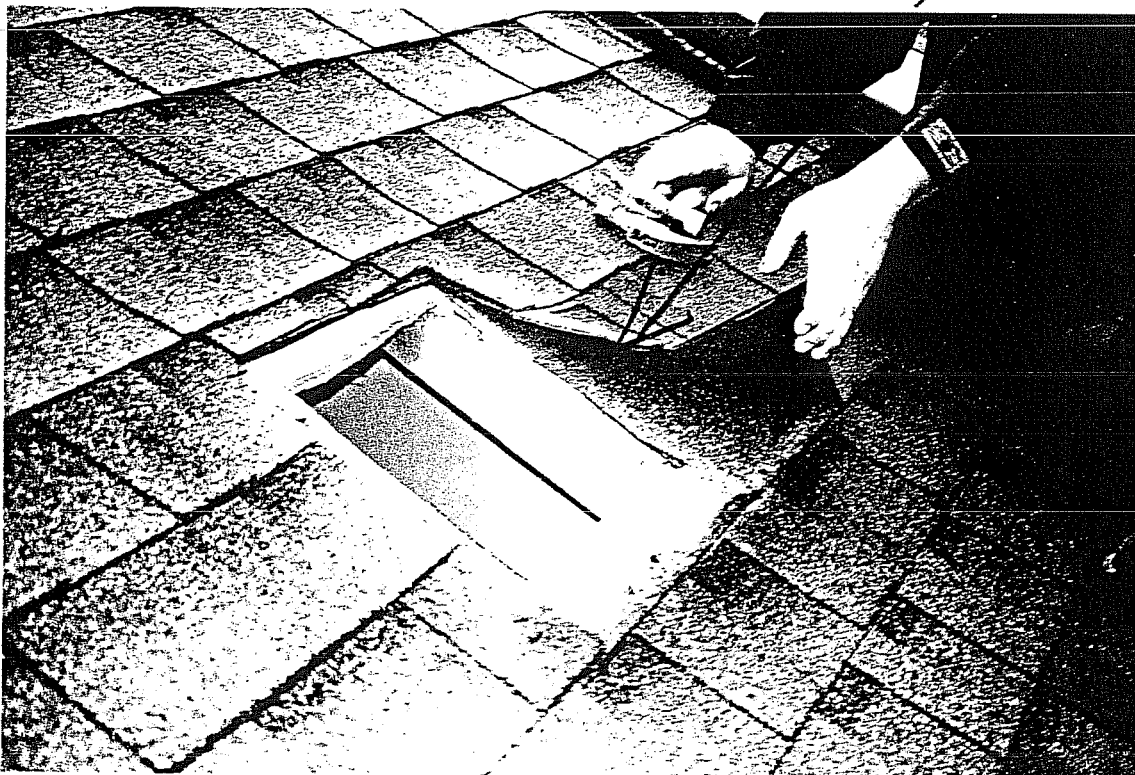
34

MOISTURE STAINS

NO "FELT" UNDER LAY

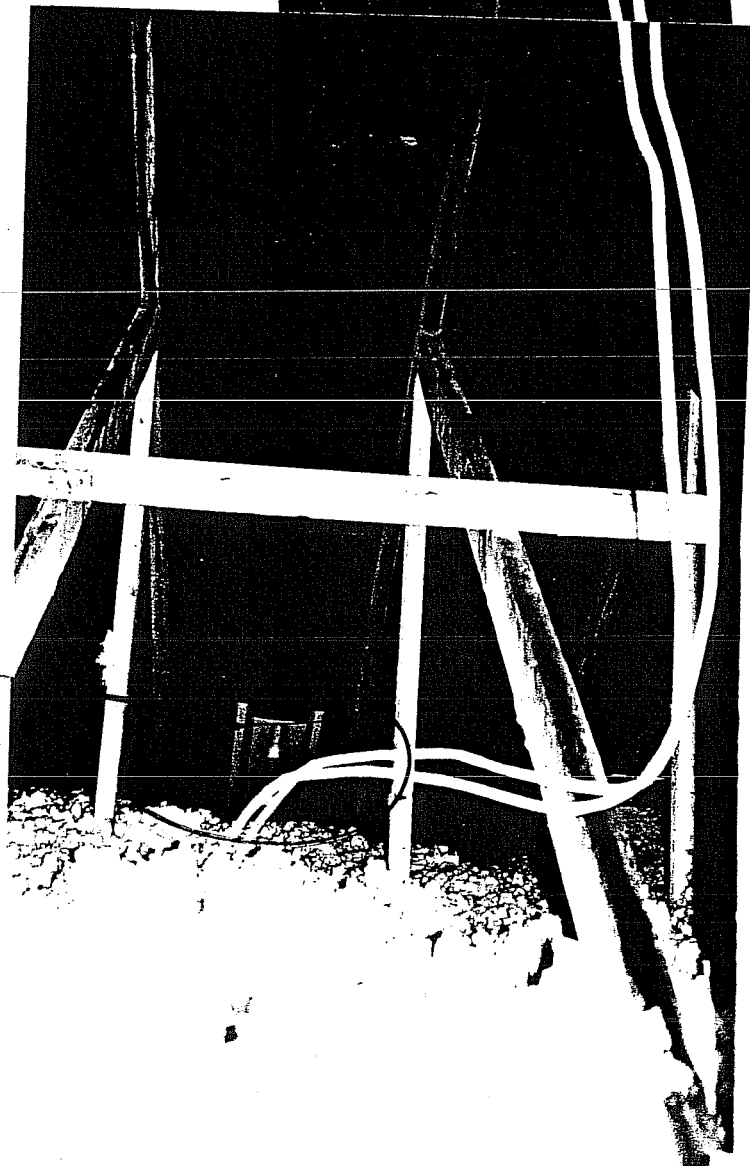
35B

MINIMUM
SOFFIT
VENTILATION

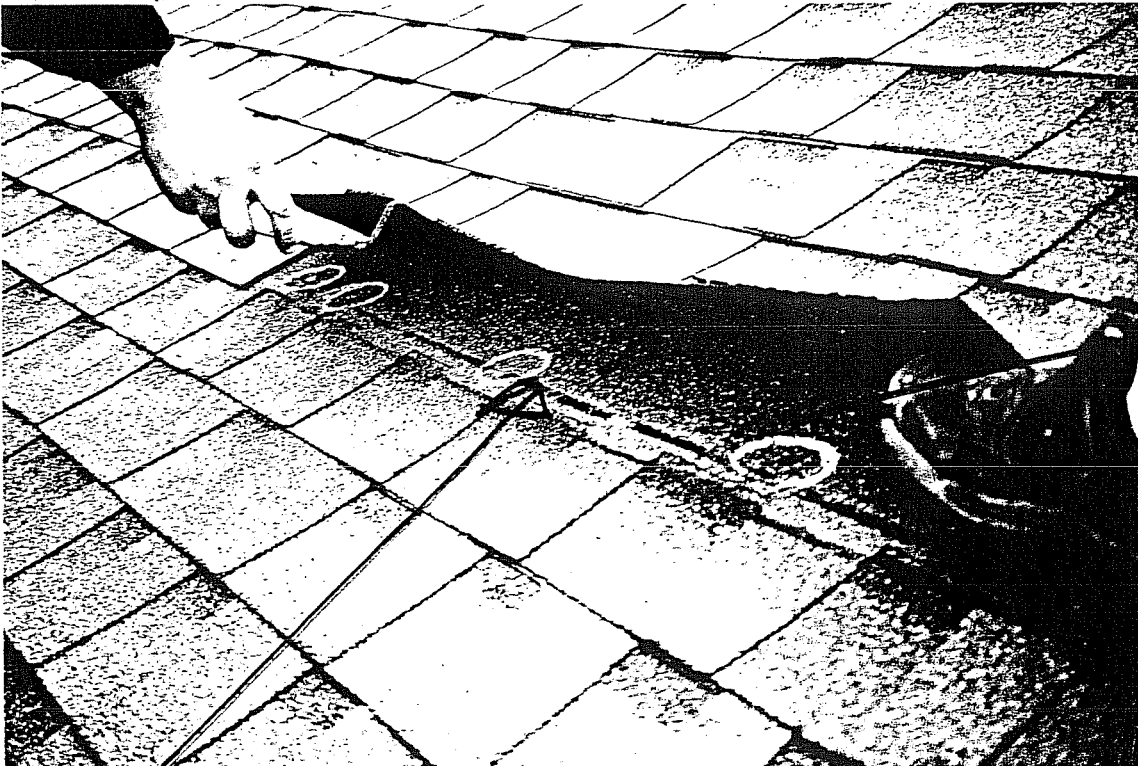
37

(A) NAILS INSTALLED ABOVE SEALING STRIP

(B)
RUSTED
NAIL HEADS

SELF ADHESIVE STRIP HAS
MINIMAL STRENGTH

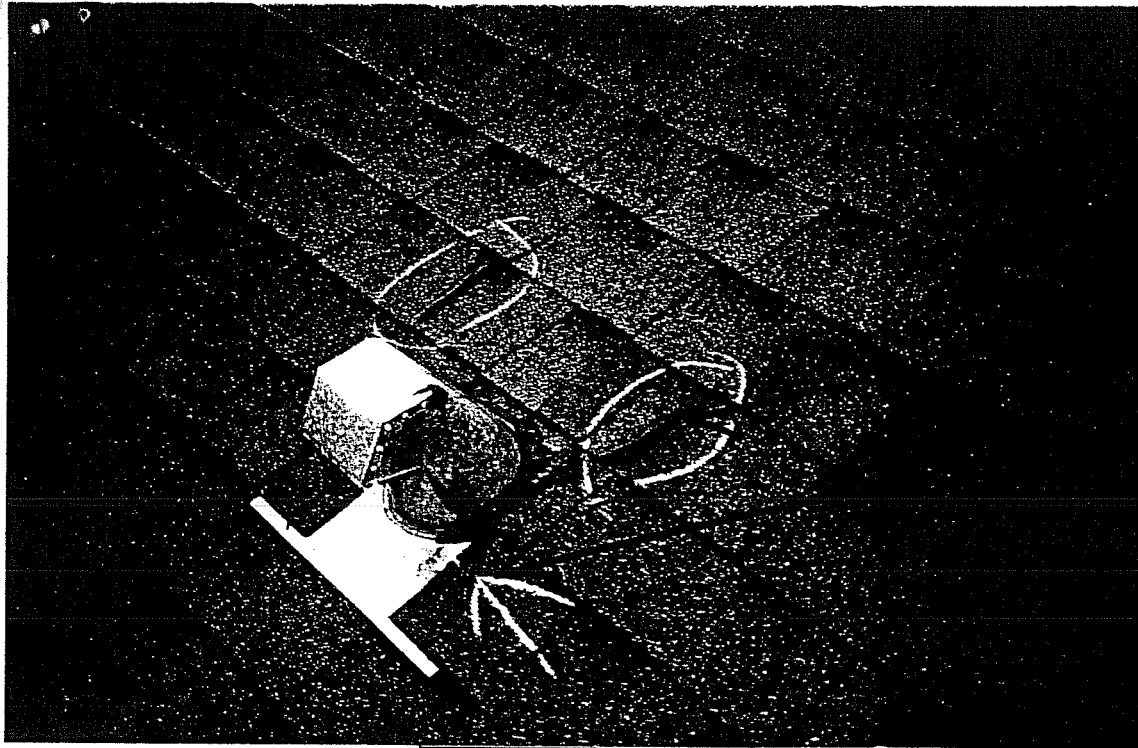
39

VERY POORLY
INSTALLED
VENT STACK
— MASTIC
— SAW CUT

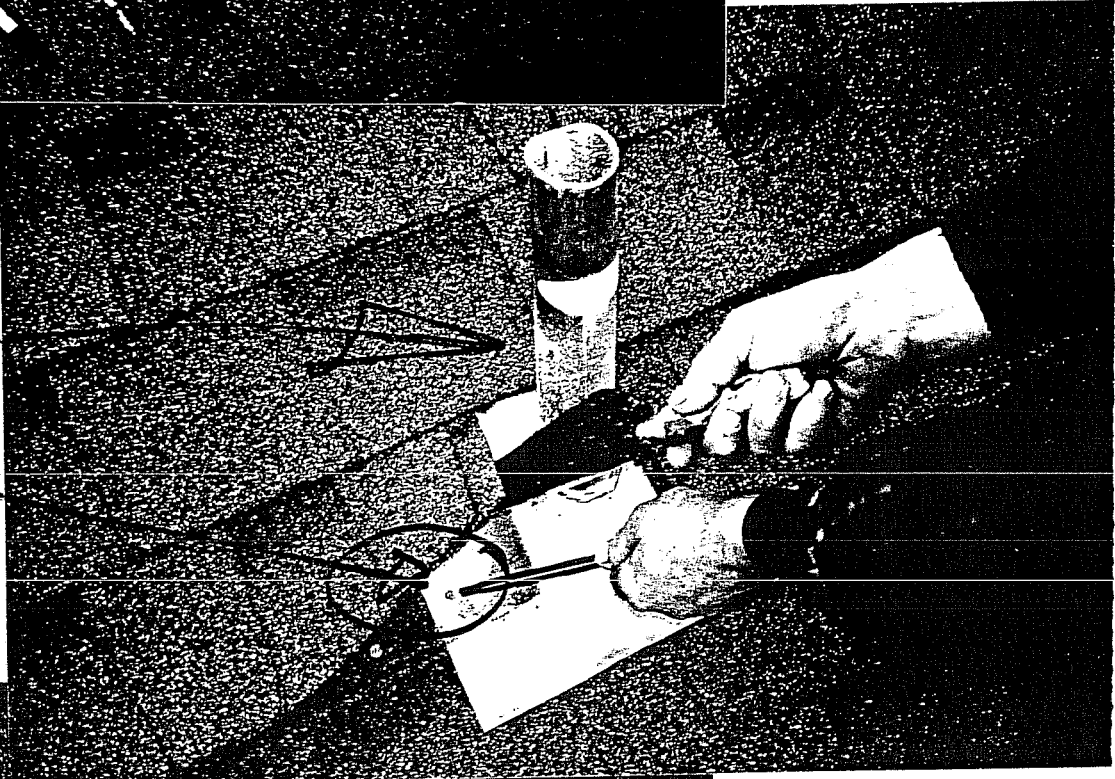
CONDENSATION
ON INSIDE OF
PIPE, + LEAD NOT
CUT OFF, + NO
LEAD CAP —
LOW NAIL ON
VENT STACK
FLANGE

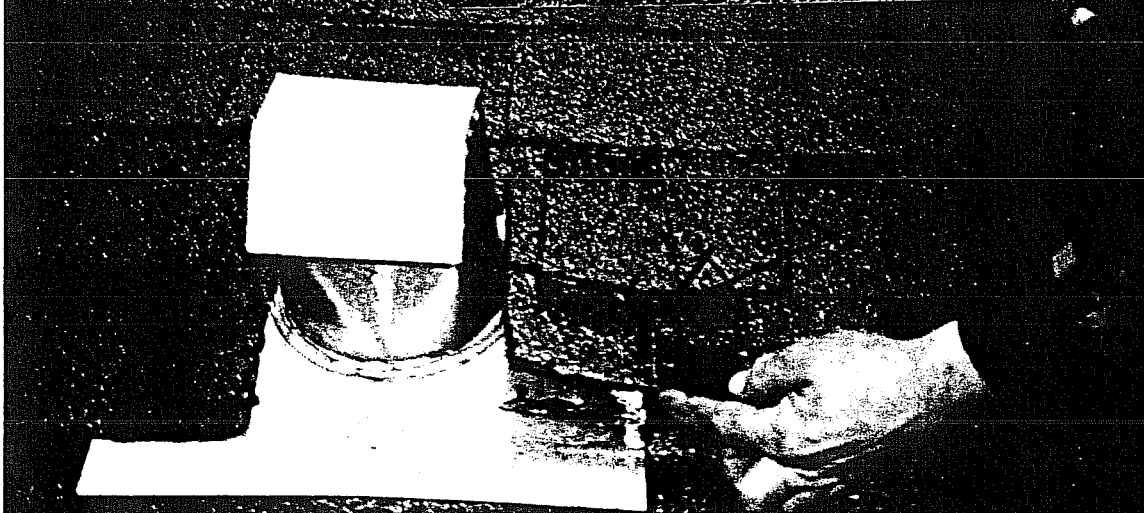
40

SHINGLES
SIDE LAP @
FLANGE EDGE
WITH CAULKING
"PATCH" UNDER
SHINGLE, VERY
POOR INSTALLATION
