Re : LMS 2503 – Terravita Place
868 Cassiar Street, Vancouver, BC
Our Reference : 01-448

As requested, an on-site inspection was performed on two separate structures that included three units. The following was found:

JPJ/sd (Inspection 01-448 Dorset re Terravita)

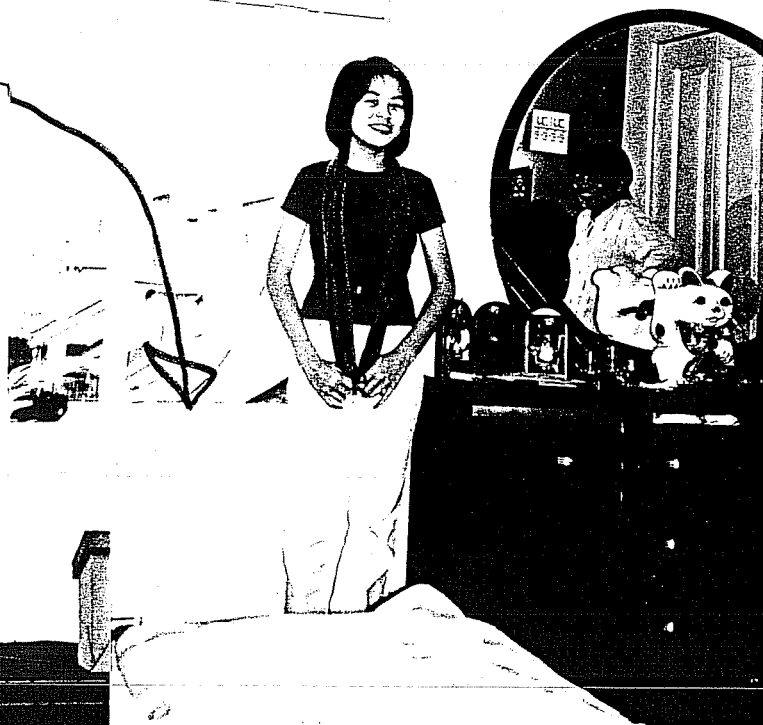
41

UNIT # 57

WINDOW STAINING
