Building Enclosure Warranty Review

The Parkhill, 7108 Edmonds Street, Burnaby, BC

PROJECT # 1751.50

DATE January 27, 2011

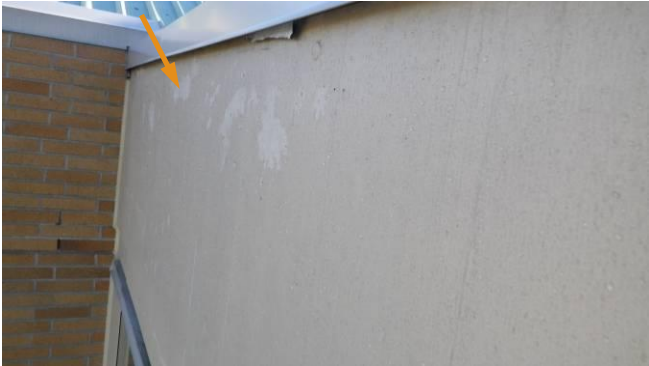
Fig. 2.1.2 Elastomeric paint on concrete wall is scuffed, east elevation.

RECOMMENDATION	
1	Elastomeric coatings are typically thin (~10mils) and fragile. As part of the regular maintenance program, any areas of the coating which are damaged should be identified and repaired.

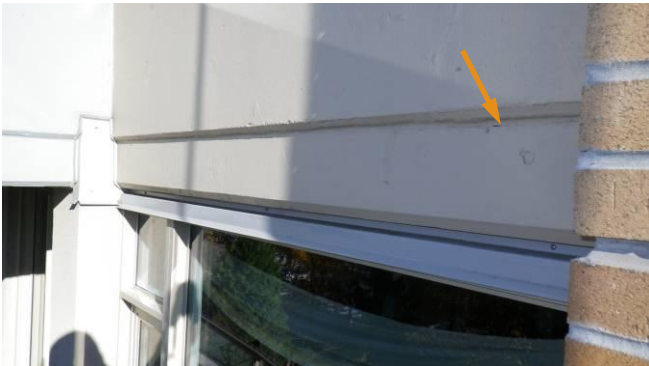
- Sealant cracking at concrete cold joint on the 5th floor, west elevation (Fig. 2.1.3).

Significance: Reduced water resistance at the face of the exterior wall.

Fig. 2.1.3 Sealant cracking at concrete cold joint on the 5th floor, west elevation.

RECOMMENDATION	
2	As part of the regular maintenance program, any areas of the sealant discontinuity at architectural concrete should be identified and repaired.

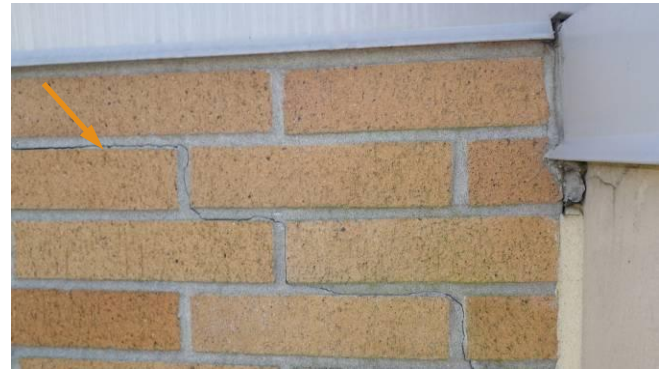
- Localized cracking of the brick masonry mortar joints on the 10th floor, northeast corner, and the 4th floor, west elevation (Fig. 2.1.5 to Fig. 2.1.6). This was reported in the 2 Year Warranty Review Report dated Dec. 11, 2007.

Fig. 2.1.5 Localized cracking of the brick masonry mortar joints on the 10th floor, northeast corner (north facing).

RECOMMENDATION	
3	Monitor brick masonry mortar joints hairline cracks. Periodic maintenance tasks, such as re-pointing, should be considered to address the minor aesthetic and water shedding performance issues associated with masonry joint cracking.
4	As part of the regular maintenance program, any areas of sealant discontinuity at brick masonry veneer should be identified and repaired.

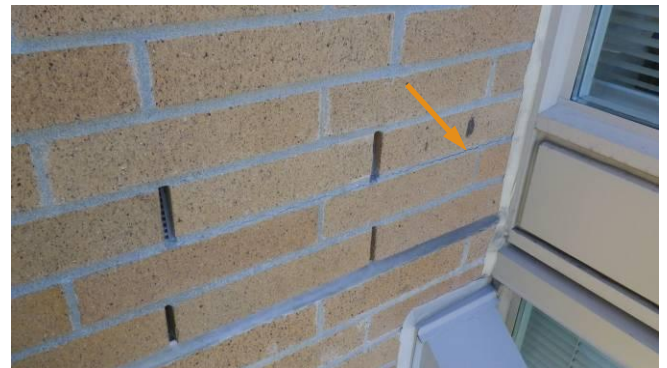
Fig. 2.1.6 Localized cracking of the brick masonry mortar joints on the 4th floor, west elevation.

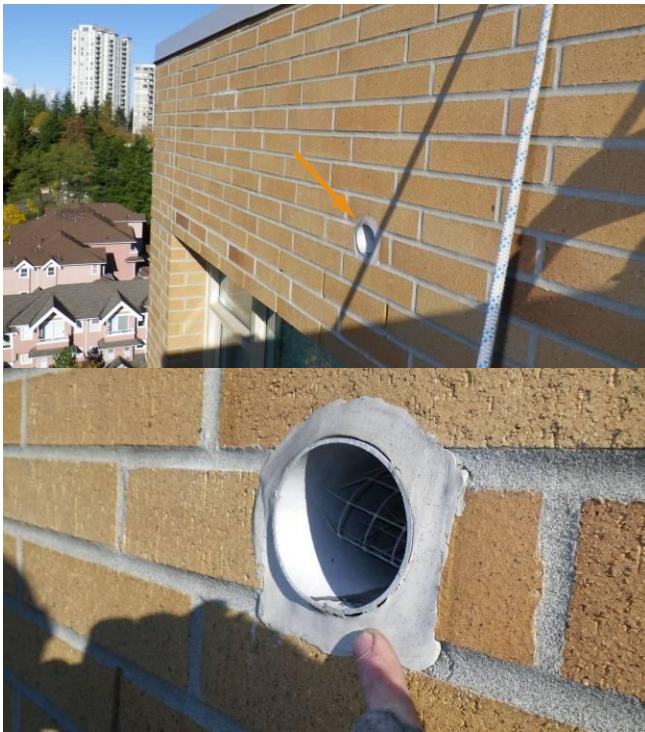
- Sealant cracking at the roof overflow to the brick masonry veneer interface on the west elevation (Fig. 2.1.7).

Fig. 2.1.7 Sealant cracking at the roof overflow to brick masonry veneer interface, west elevation.

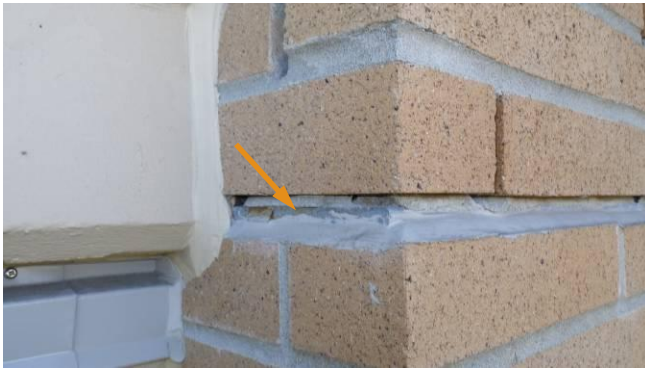
- Discontinuous sealant at shelf angle on the east elevation, 10th floor (Fig. 2.1.8).

Significance: Reduced water resistance at the face of the exterior wall.

Fig. 2.1.8 Discontinuous sealant at the shelf angle, east elevation of the 10th floor.

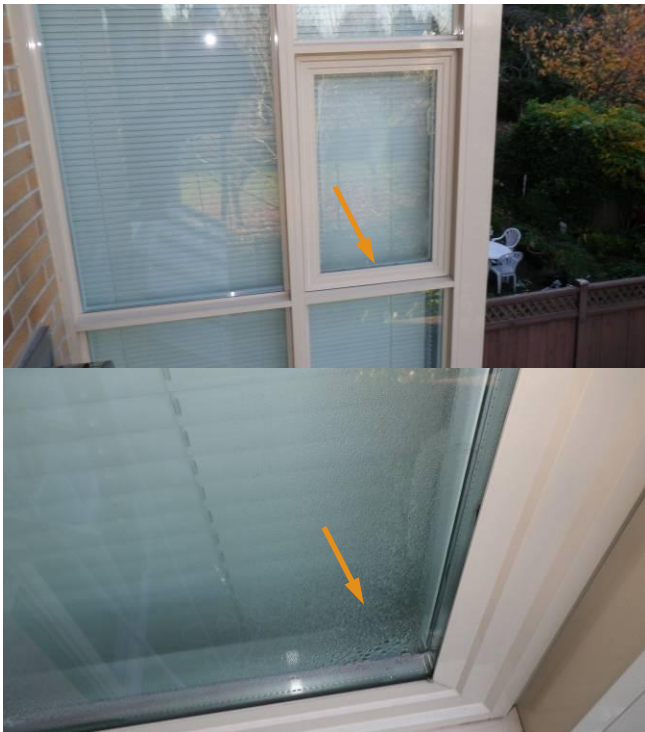
- A failed insulating glass unit (IGU) was identified at the second floor, east elevation (Fig. 2.2.2), and was reported at Suite 102 (Appendix A).

Significance: It is a nuisance to occupants. The sealed units should be replaced under the 10 year extended warranty for the sealed units.

Fig. 2.2.2 Failed insulating glass unit on the 2nd floor, east elevation.

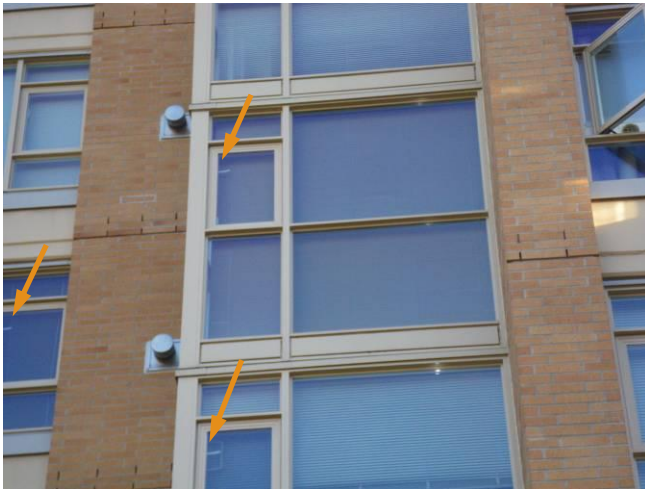
Significance: If windows are not properly closed with both handles, the closed handle could become loose as it is subjected to greater forces compared to the condition where both handles are used. If only one handle is used, the sash is not fully sealed in a lock position, which may result in air and water leakage.

Fig. 2.2.3 Window upper handles were not used, south elevation.

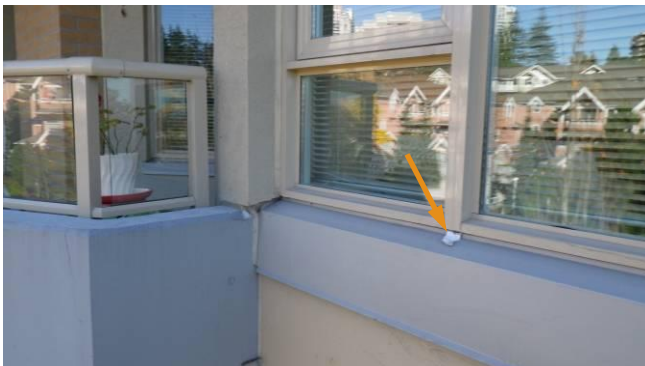
Fig. 2.2.4 Identification labels were not removed prior to sealant installation at various window sections.

RECOMMENDATION	
5	Owners to control interior relative humidity level. To reduce risk of condensation, air circulation should be encouraged through the use of bathroom and kitchen fans, leaving drapes and blinds open when possible, opening windows and keeping the interior temperature at around 20°C relative humidity below 50% during heating season.
6	Replace failed IGUs per window manufacturer's warranty.
7	Owners to use both window handles when windows in closed position.
8	Adjustment to window hardware required as part of annual maintenance.
9	Remove identification labels and sealant and applying new sealant.

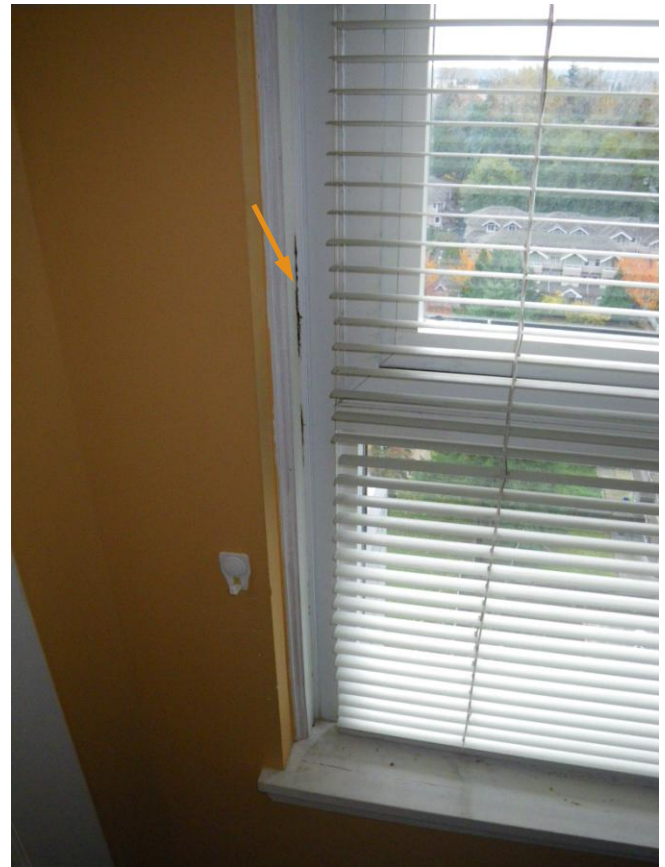
- Mould was reported at the sealant between the window frame and the interior finishes at Suite 1003 (Fig. 2.2.5). It was determined during the suite visit that the stained sealant was due to self-adhesive membrane in contact with the interior acrylic sealant.

Significance: It is an aesthetic issue.

Fig. 2.2.5 Reported mould, Suite 1003.

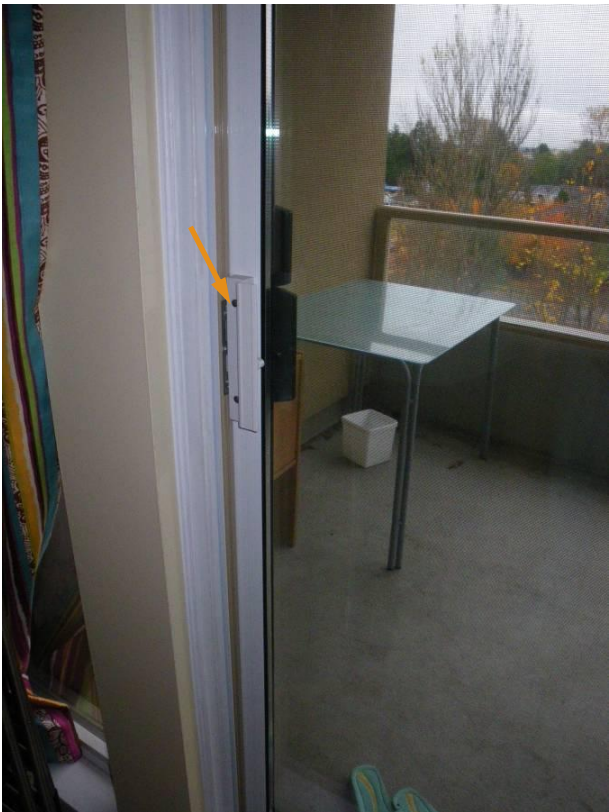
• Several owners reported operational difficulties with sliding doors or swing doors (Appendix A and Fig. 2.2.6 to Fig. 2.2.7).

Significance: Besides being a nuisance, door operational difficulty can result in air and water leakage. Some doors may require adjustment from time and time and this can be performed as part of the annual maintenance review.

Fig. 2.2.6 The sliding door is hard to operate, Suite 503.

RECOMMENDATION	
10	Adjustment to door hardware required as part of annual maintenance.

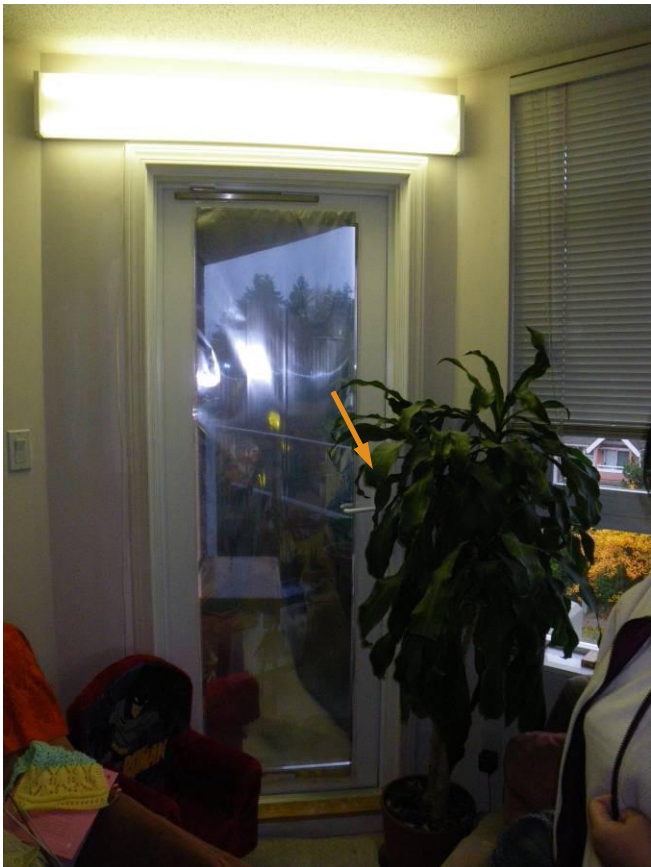
Fig. 2.2.7 The swing door is hard to operate, Suite 606.

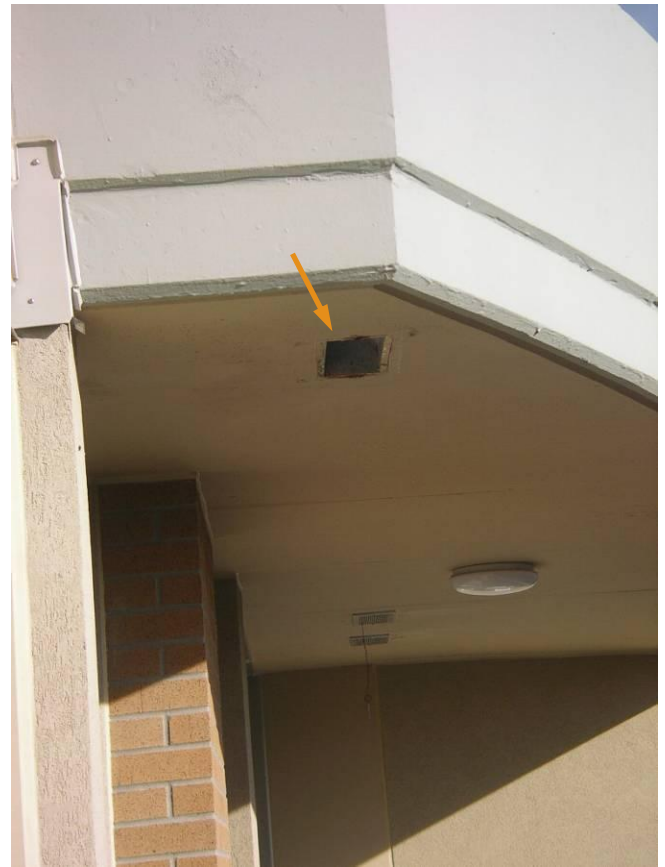
- At the south elevation of the 5th and 8th floors, there is an exhaust grill missing from an in-slab discharge vent at each location (Fig. 2.2.9). This was reported in the 2 Year Warranty Review Report dated Dec. 11, 2007.

Significance: The large vent openings can lead to pest entry. These should be replaced as part of the maintenance program.

Fig. 2.2.2.9 Missing exhaust grill from in-slab discharge vents on the 5th and the 8th floors, south elevation.

RECOMMENDATION	
11	Replace the missing exhaust grills at the in-slab discharge vents on the 5 th and 8 th floors, south elevation.

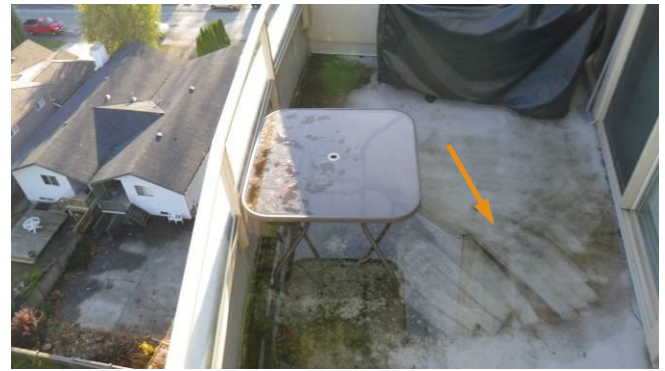
- ❖ Water ponding was reported at several balconies (Appendix A); we observed minor water ponding at the balcony of Suite 1004 (Fig. 2.3.2).

Significance: Elimination of all ponding is not required. Even with adequate sloping, water drainage can be restricted due to the membrane surface characteristics. Localized, minor, water ponding on balcony surfaces is expected, considering the original as-built conditions. Any remaining water will gradually dry.

Fig. 2.3.2 Minor water ponding at Suite 1004.

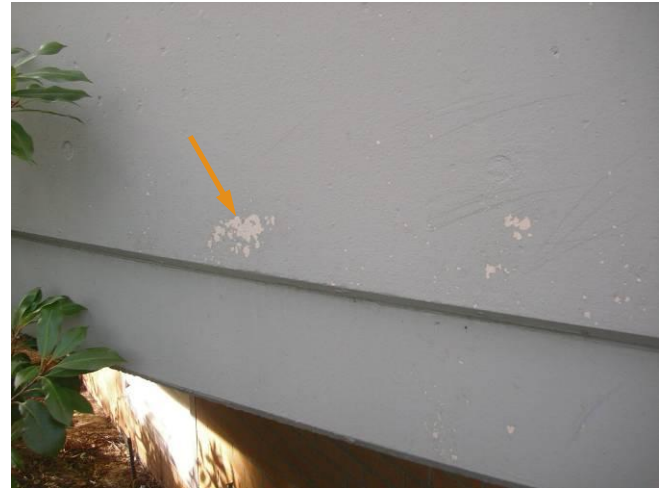
- ❖ Minor damage to the elastomeric exterior coating on exterior face of balcony guard on the 1st floor, south elevation (Fig. 2.3.3). This was reported in the 2 Year Warranty Review Report dated Dec. 11, 2007.

Significance: Reduced water resistance at the face of the exterior wall. This issue is mainly aesthetic as the parapet is a fully exterior component. As part of annual maintenance, damaged coating can be repaired by reapplying paint coating.

Fig. 2.3.3 Minor damage to exterior coating on exterior face of balcony on level 1, south elevation.

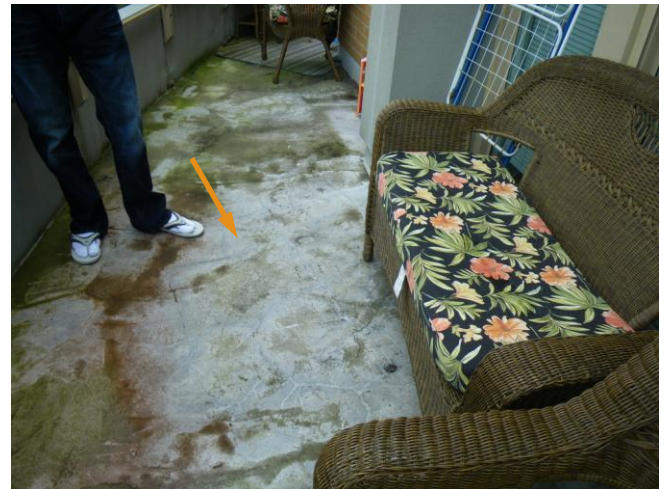
- ❖ At Suite 1003, a cement topping was applied over the traffic coating. The Owner indicated that tile would eventually be installed.

Significance: The cement installation is incomplete and makes it difficult/impossible to service/repair the traffic coating.

Fig. 2.3.4 A cement topping was applied over the traffic coating, Suite 1003.

RECOMMENDATION	
	renewals program.
14	Strata needs to follow-up with the Owner of Suite 1003 regarding how the balcony will be reinstated.

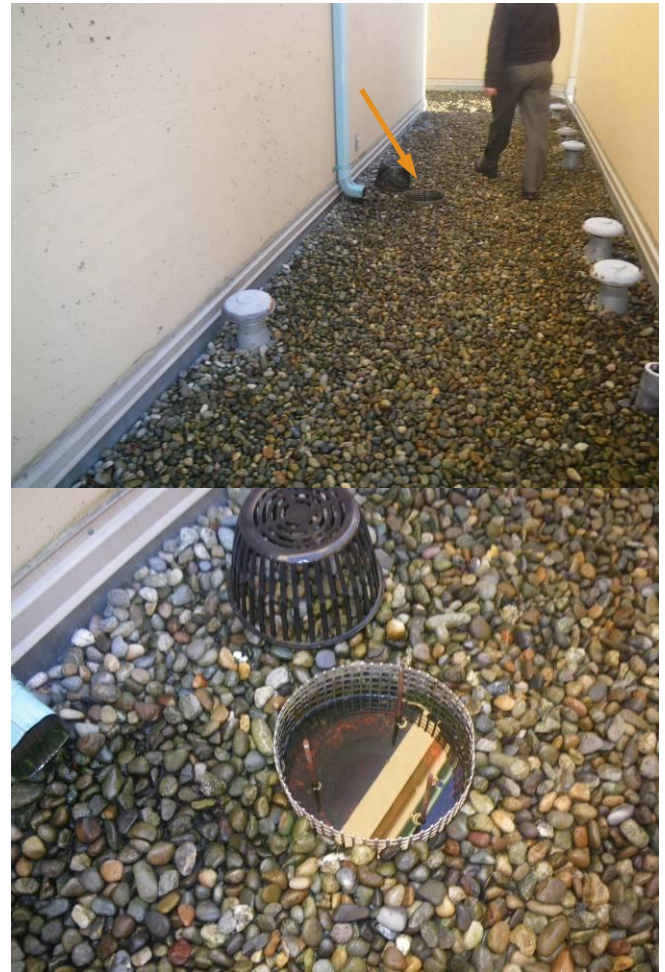
- Clogged drain on the main roof (Fig. 2.4.3).

Significance: Reduced water drainage and increased possibility of water ingress.

Fig. 2.4.3 Clogged drain on the main roof.

RECOMMENDATION	
15	Provide maintenance to all roof drains.

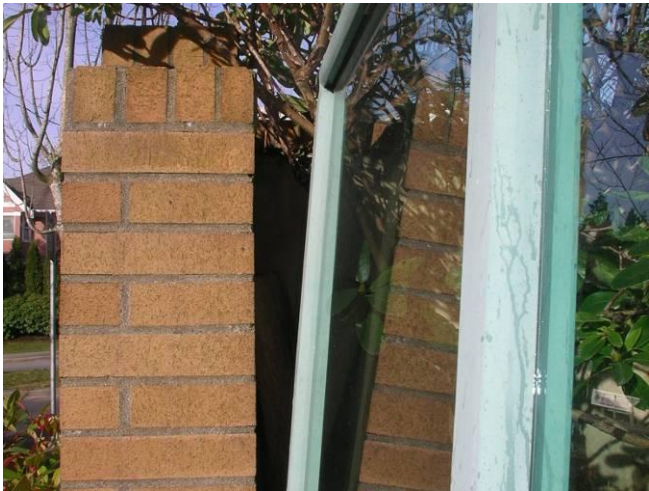
- The west-facing patio guard at Suite 101 is not adequately secured to the brick masonry (Fig. 2.5.2). This was reported in the 2 Year Warranty Review Report dated Dec. 11, 2007.

Significance: Safety issue, and should be addressed.

Fig. 2.5.2 The west-facing patio guardrail at Suite 101 is not adequately secured to the brick masonry.

RECOMMENDATION	
16	Secure the west-facing patio guardrail at Suite 101 to the brick masonry.
